# **Intel<sup>®</sup> Communications Chipset 8900 Series**

**Specification Update**

***May 2014***

**Document Number: 328000-005US**

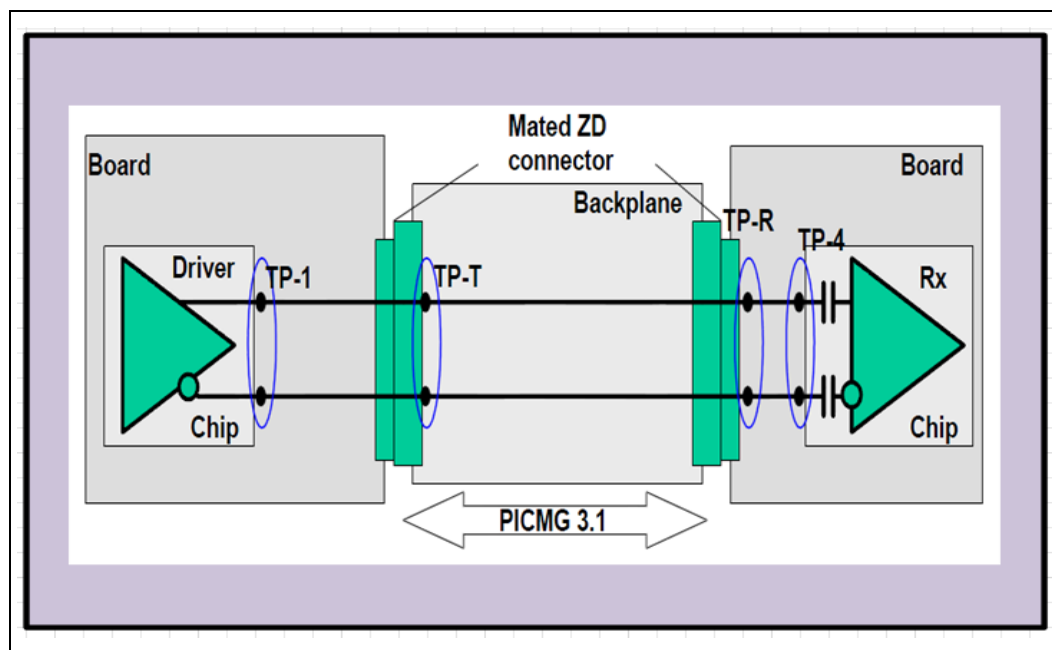
**Figure 2. 1000BASE-BX/FC-Pi Transmitter Electrical Specifications**

#### 75. GbE: GbE Interface Transmit Voltage Level Specification Violation

**Implication:** Although this is a specification violation, it does not affect the functional operation of the interface.

**Workaround:** Ensure that the signal routing length from TP-1 to TP-4 is greater than 10". Refer to *Intel® Communications Chipset 8900 Series Platform Design Guide (PDG)* for maximum routing length. (See [Figure 2.](#))
