Intel[®] Communications Chipset 8900 Series

Specification Update

May 2014

Document Number: 328000-005US

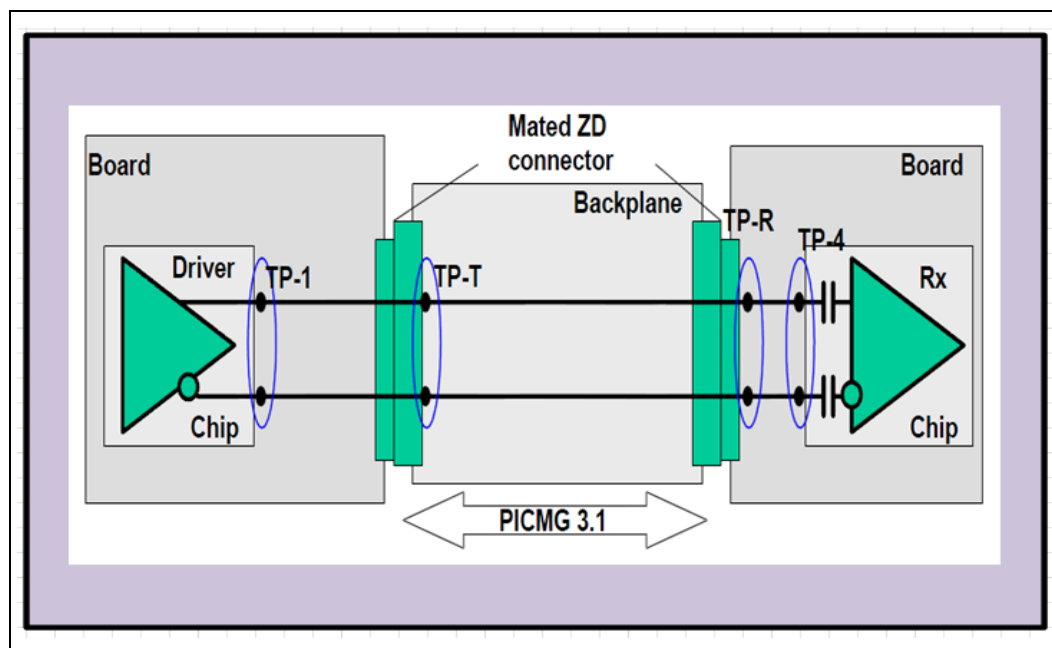
Figure 2. 1000BASE-BX/FC-Pi Transmitter Electrical Specifications

75. GbE: GbE Interface Transmit Voltage Level Specification Violation

Implication: Although this is a specification violation, it does not affect the functional operation of the interface.

Workaround: Ensure that the signal routing length from TP-1 to TP-4 is greater than 10". Refer to *Intel® Communications Chipset 8900 Series Platform Design Guide (PDG)* for maximum routing length. (See [Figure 2.](#))
